### Project Background

Mackworth designed a turbidity containment and fish exclusion barrier as an alternative to a temporary sheet pile cofferdam as part of a shoreline remediation project in Portland, Maine. The remediation took place in Portland Harbor along a selection of the Fore River and included installation of an impermeable bulkhead to contain a seep area, excavation, and stabilization of impacted soil and sediment (Figure 1).

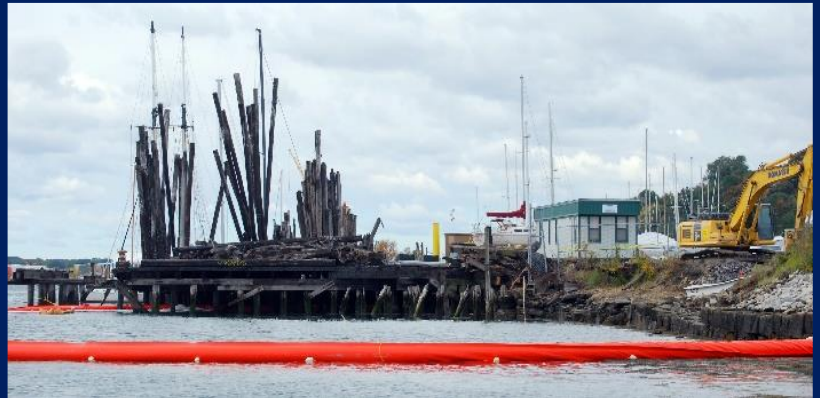
Figure 1. Portland Harbor, Maine. The system contains sediments, associated contaminants, and excludes fish and marine mammals, while allowing water passage.

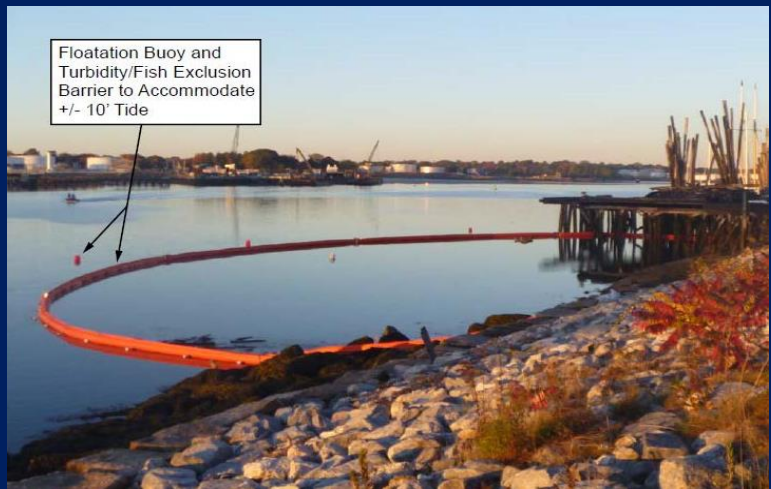
Figure 2. Close up view of the turbidity and fish exclusion system

The design process included a bottom structural survey of the anticipated barrier alignment area as well as loading calculations to address barrier structure and anchoring requirements. The barrier was constructed of three layers. Two outer layers were designed for strength and durability, and an inner layer that worked as the primary filtration of fine sediments (Figure 3). Flotation consisted of 2 lb (0.9 kg) density polystyrene billets, 16 in (40.6 cm) in diameter. Anchoring consisted of helical anchors along the outer perimeter of the barrier. These anchors were selected due to their superior holding power and low profile to the river bottom. The bottom seal was achieved by incorporating an impermeable “T” bottom skirt with the outer skirt twice the length of the inner skirt. This design allowed sealing during various flow directions. At the end of each skirt a 1/2 in (1.3 cm) ballast chain was installed to ensure the skirt maintained contact with the bottom. The barrier was attached and sealed to the shoreline using a custom vertical T-shaped impermeable piece. The T-piece was connected to the seawall granite blocks with a combination of 5/8 in (1.6 cm) eye bolts which were epoxied into the blocks and ballast chain. A sorbent boom was installed from shore to shore inside of this turbidity/fish exclusion barrier.

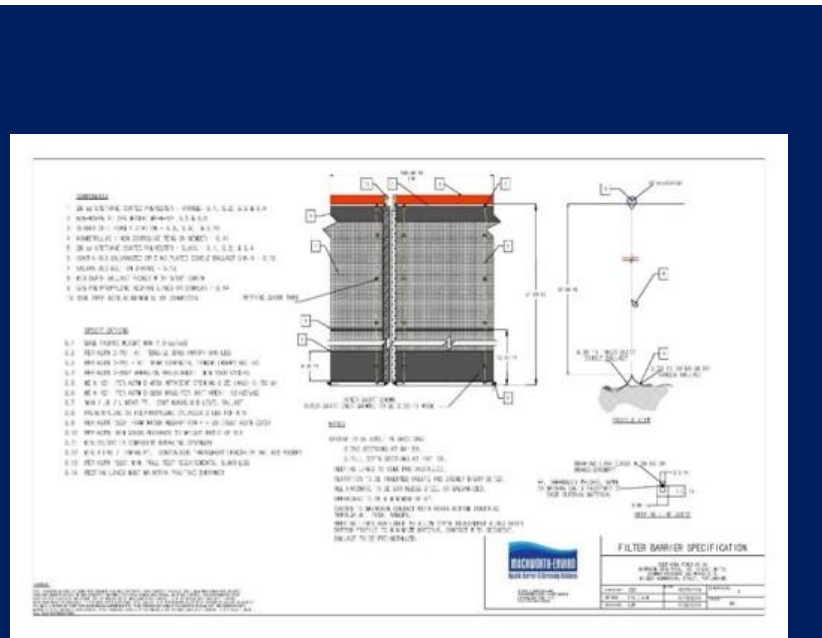
Figure 3. Filter barrier specification drawing
