Client: ARCO / Pioneer Technical

Project Background

The cleanup of Silver Bow Creek is an ongoing Superfund remedial effort coordinated by the Montana Department of Environmental Quality (DEQ) in collaboration with the U.S. Environmental Protection Agency (EPA). Pioneer Technical is currently responsible for the treatment site operations.

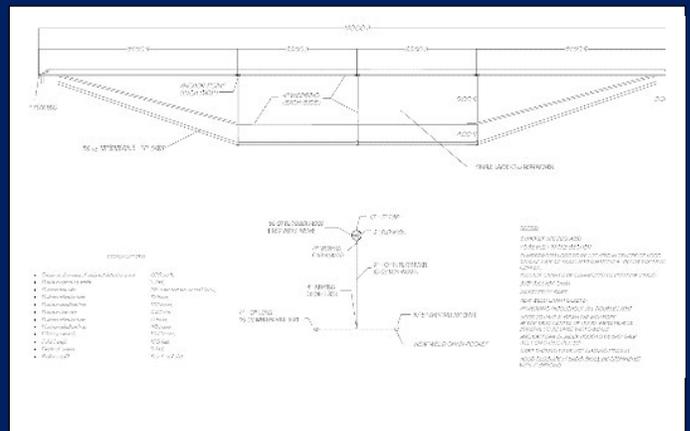
Figure 1. Cross section of barrier. This drawing was for the McLaren Mine also in MT. The barrier for this project had similar dimensions, just twice as long.

The final stage of the reclamation and groundwater treatment process involved channeling the water through a series of five treatment lagoons. Each lagoon was equipped with a bottom-sealing filter barrier, enabling suspended sediments to

settle out before the water advanced to the next lagoon. By the time the water exited the lagoon system, it had been thoroughly purified and was ready to safely enter Silver Bow Creek in pristine condition.

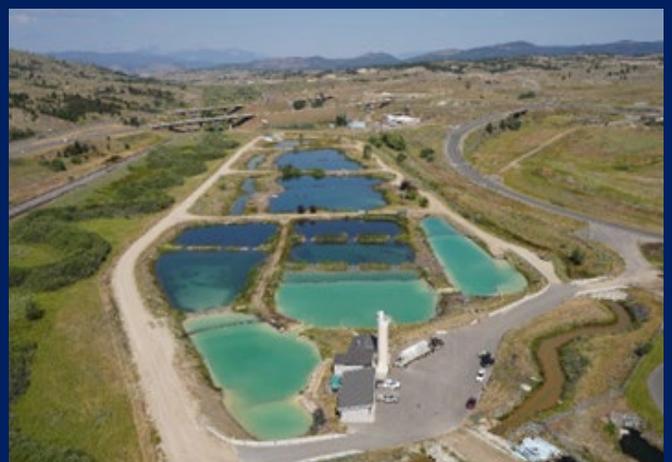
Figure 2. Aerial view of barriers within the lagoon system

Originally installed in 2010, the five bottom-sealing filter barriers of varying lengths operated year-round, including through icy conditions, without any loss in performance. As part of routine maintenance, three of the barriers were replaced in 2024, while the remaining two continued to function effectively. Mackworth Subsea completed the installation without the need to dewater the lagoons. The dive crew successfully assembled and deployed the new barriers in just three days, saving the client both time and costs by avoiding the dewatering process.

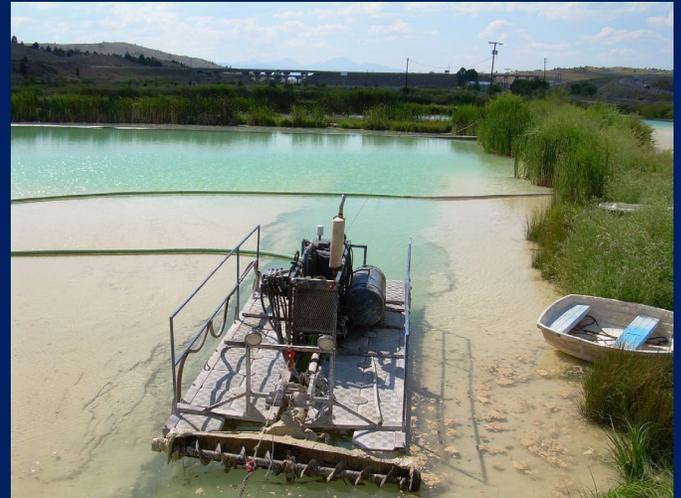
Figure 3. Pump barge and equipment

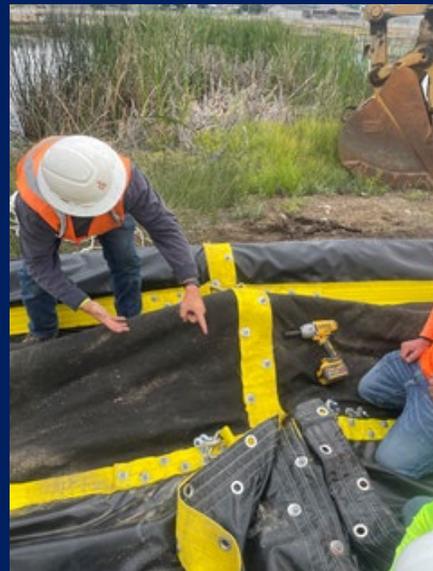
Figure 4. Assembling barrier panels on site
